Soil Sample Results from Huancavelica School Grounds - October 2019

Prepared by: Bryn Thoms, RG
Technical Lead, The EHC

Date: December 10, 2019

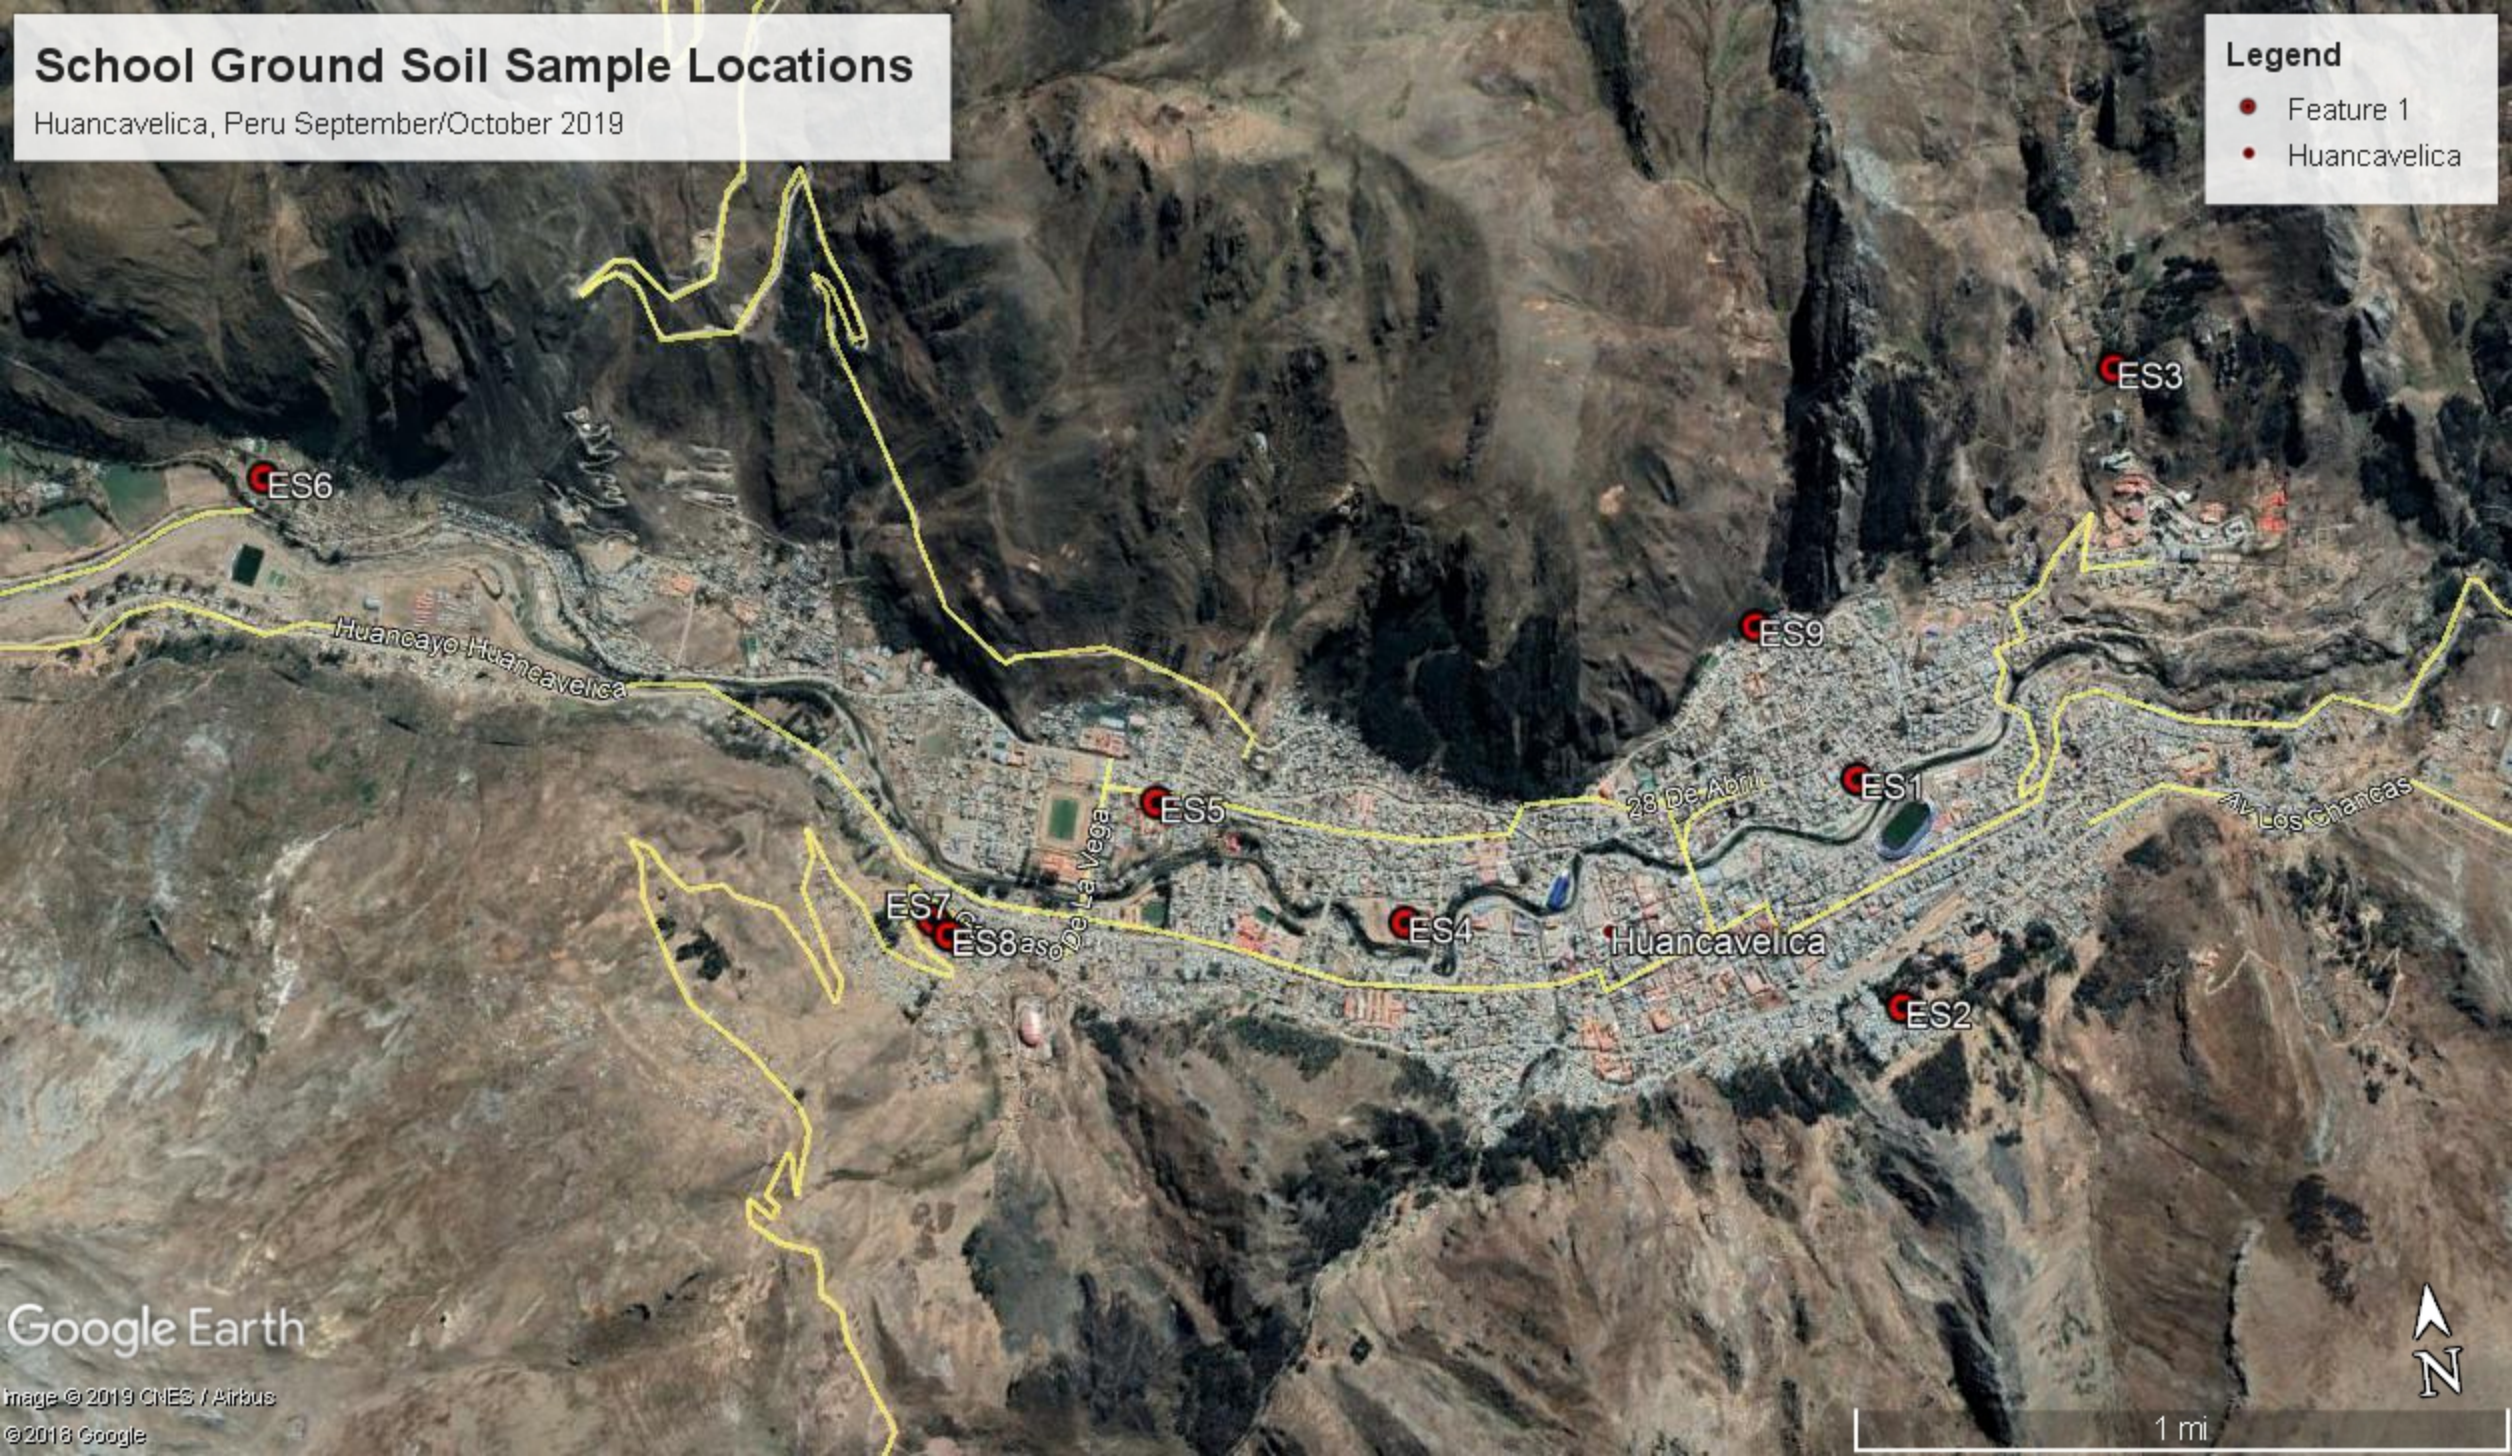
Figure - Sample Locations

On September 20, 2019 and October 10, 2019 soil samples were collected from nine school grounds for analysis of arsenic (As), mercury (Hg), and lead (Pb) to assess potential risk to children from exposure to heavy metals in shallow soil associated with historic contamination. Samples were collected from a common area where children play at each school. Five aliquots were collected from the top 5 to 8 cm of soil generally equidistant from each other throughout the play area. The aliquots were composited and homogenized to create one sample for each play area. Samples were identified by Peru's Ministry of Education school ID numbers and latitude and longitude. Sample locations are presented on the attached figure. Sample information is presented in the attached table.

School Ground Soil Sample Locations

Huancavelica, Peru September/October 2019
