Soil Evaluation of the Exterior of the School Grounds of Educational Institution N° 86399 Juan Pablo II, Huallín, Chacas District, Asunción Province, Áncash Department, Peru

Sample Collection Date: July 8, 2024

Report of Results and Recommendations

Report Date: October 25, 2025

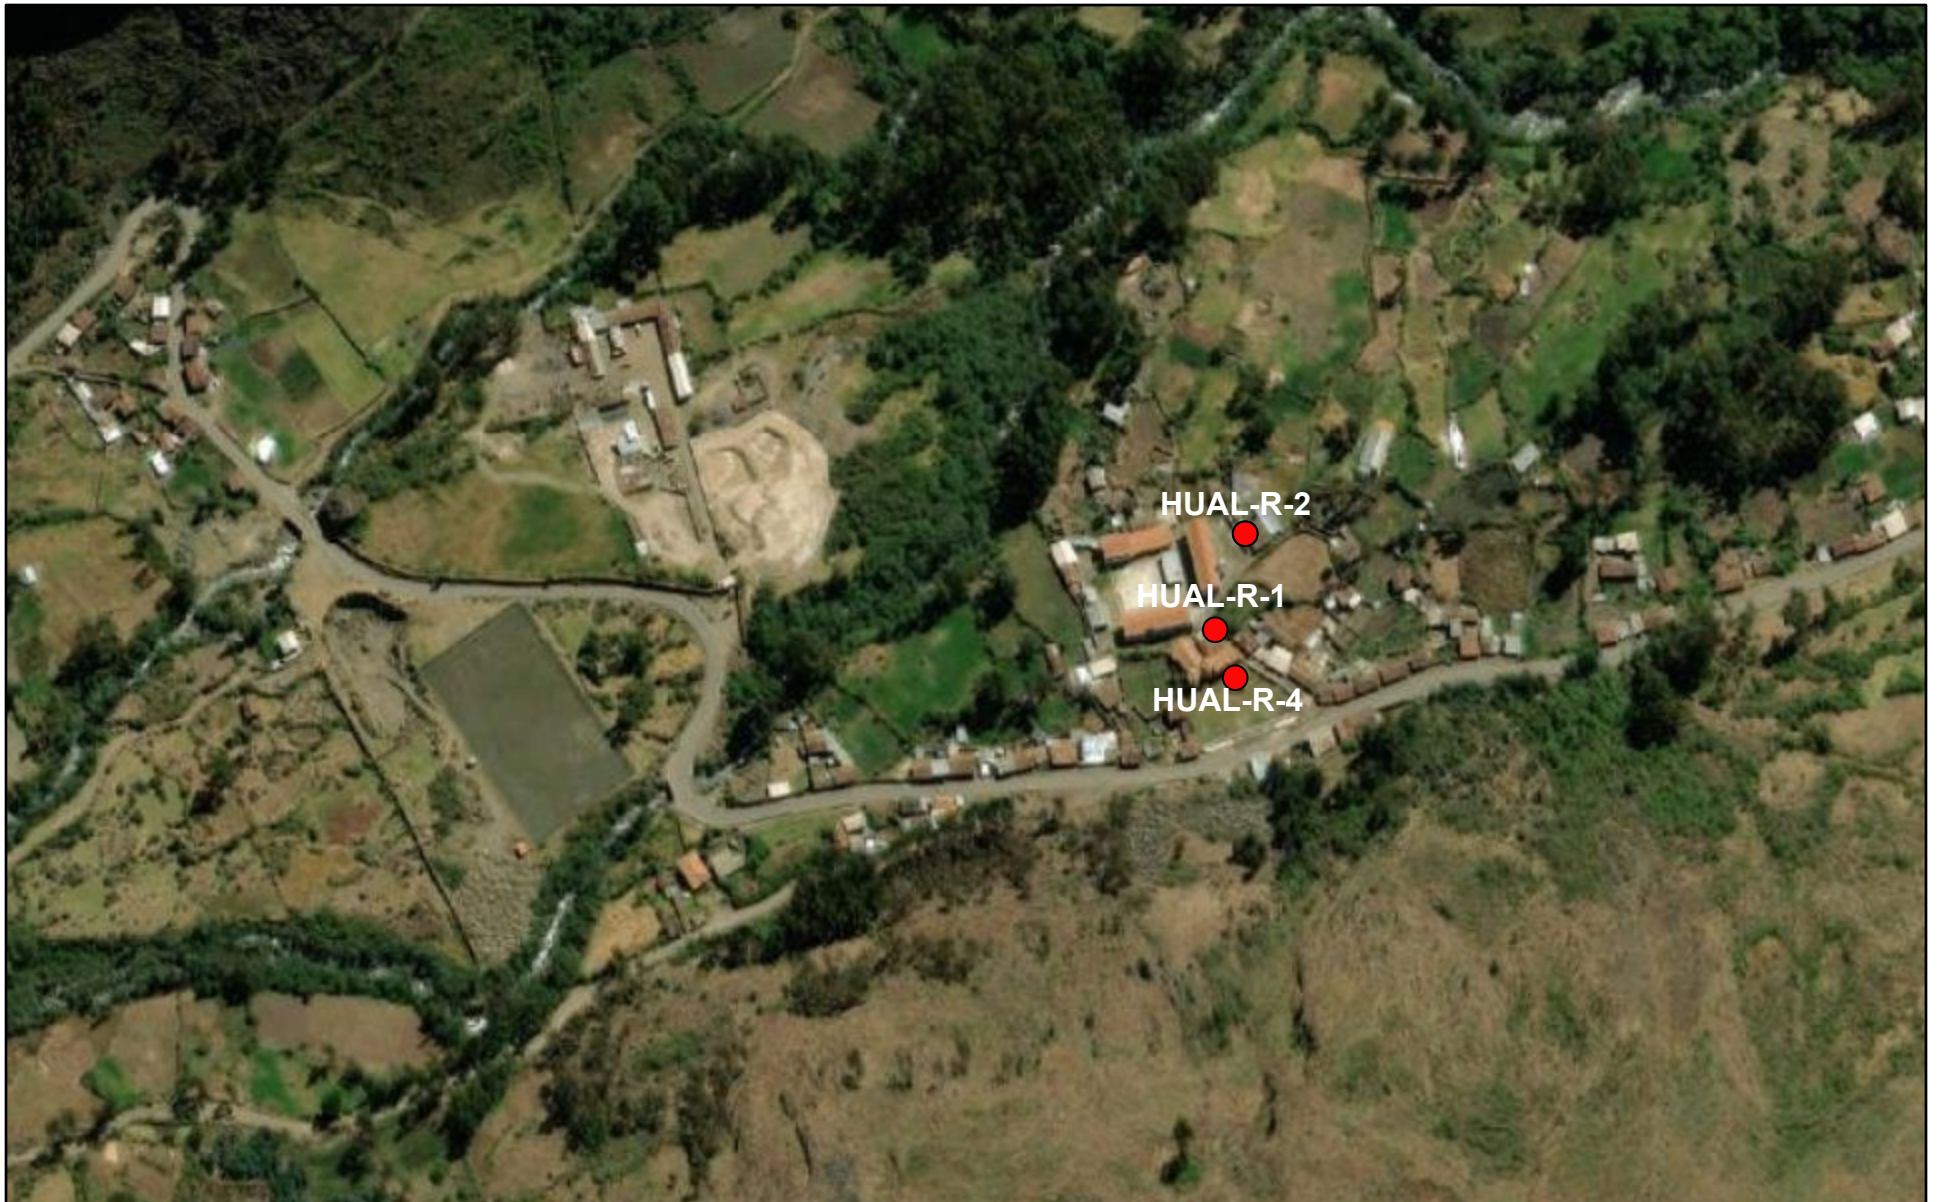
Soil Sample Locations, Huallin

Four soil samples were collected from outdoor locations, mostly from adobe walls. The attached table presents the results of samples, and the attached figure presents the locations of the samples.

Four soil samples were collected within the community of Huallín in 2024. Pb was detected at 118 mg/kg and 249 mg/kg in samples HUAL-R-1 and HUAL-R-2, respectively. These samples were collected from earthen walls within the community. HUAL-R-2 was collected adjacent to the Juan Pablo II school grounds. The rest of the sample results were below applicable ECAs.

It is important to highlight that this evaluation is based on four samples. To obtain a representative picture of soil quality across the school, a broader assessment covering different areas of the school, such as play area, gardens, and entrances is warranted. In addition, assessment of soil contamination in the broader community is also warranted.

2. Given the elevated arsenic and lead level, other areas of the school and other areas of the community should be evaluated due to the limited sampling.
