**Soil evaluation of the Soil of the Sports Field and Public Playground in  
Araqueda in the District of Cachachi, Province of Cajabamba,  
Department of Cajamarca, Peru.**

**Report of Results and Recommendations**

**Date of Report:** July 19, 2026

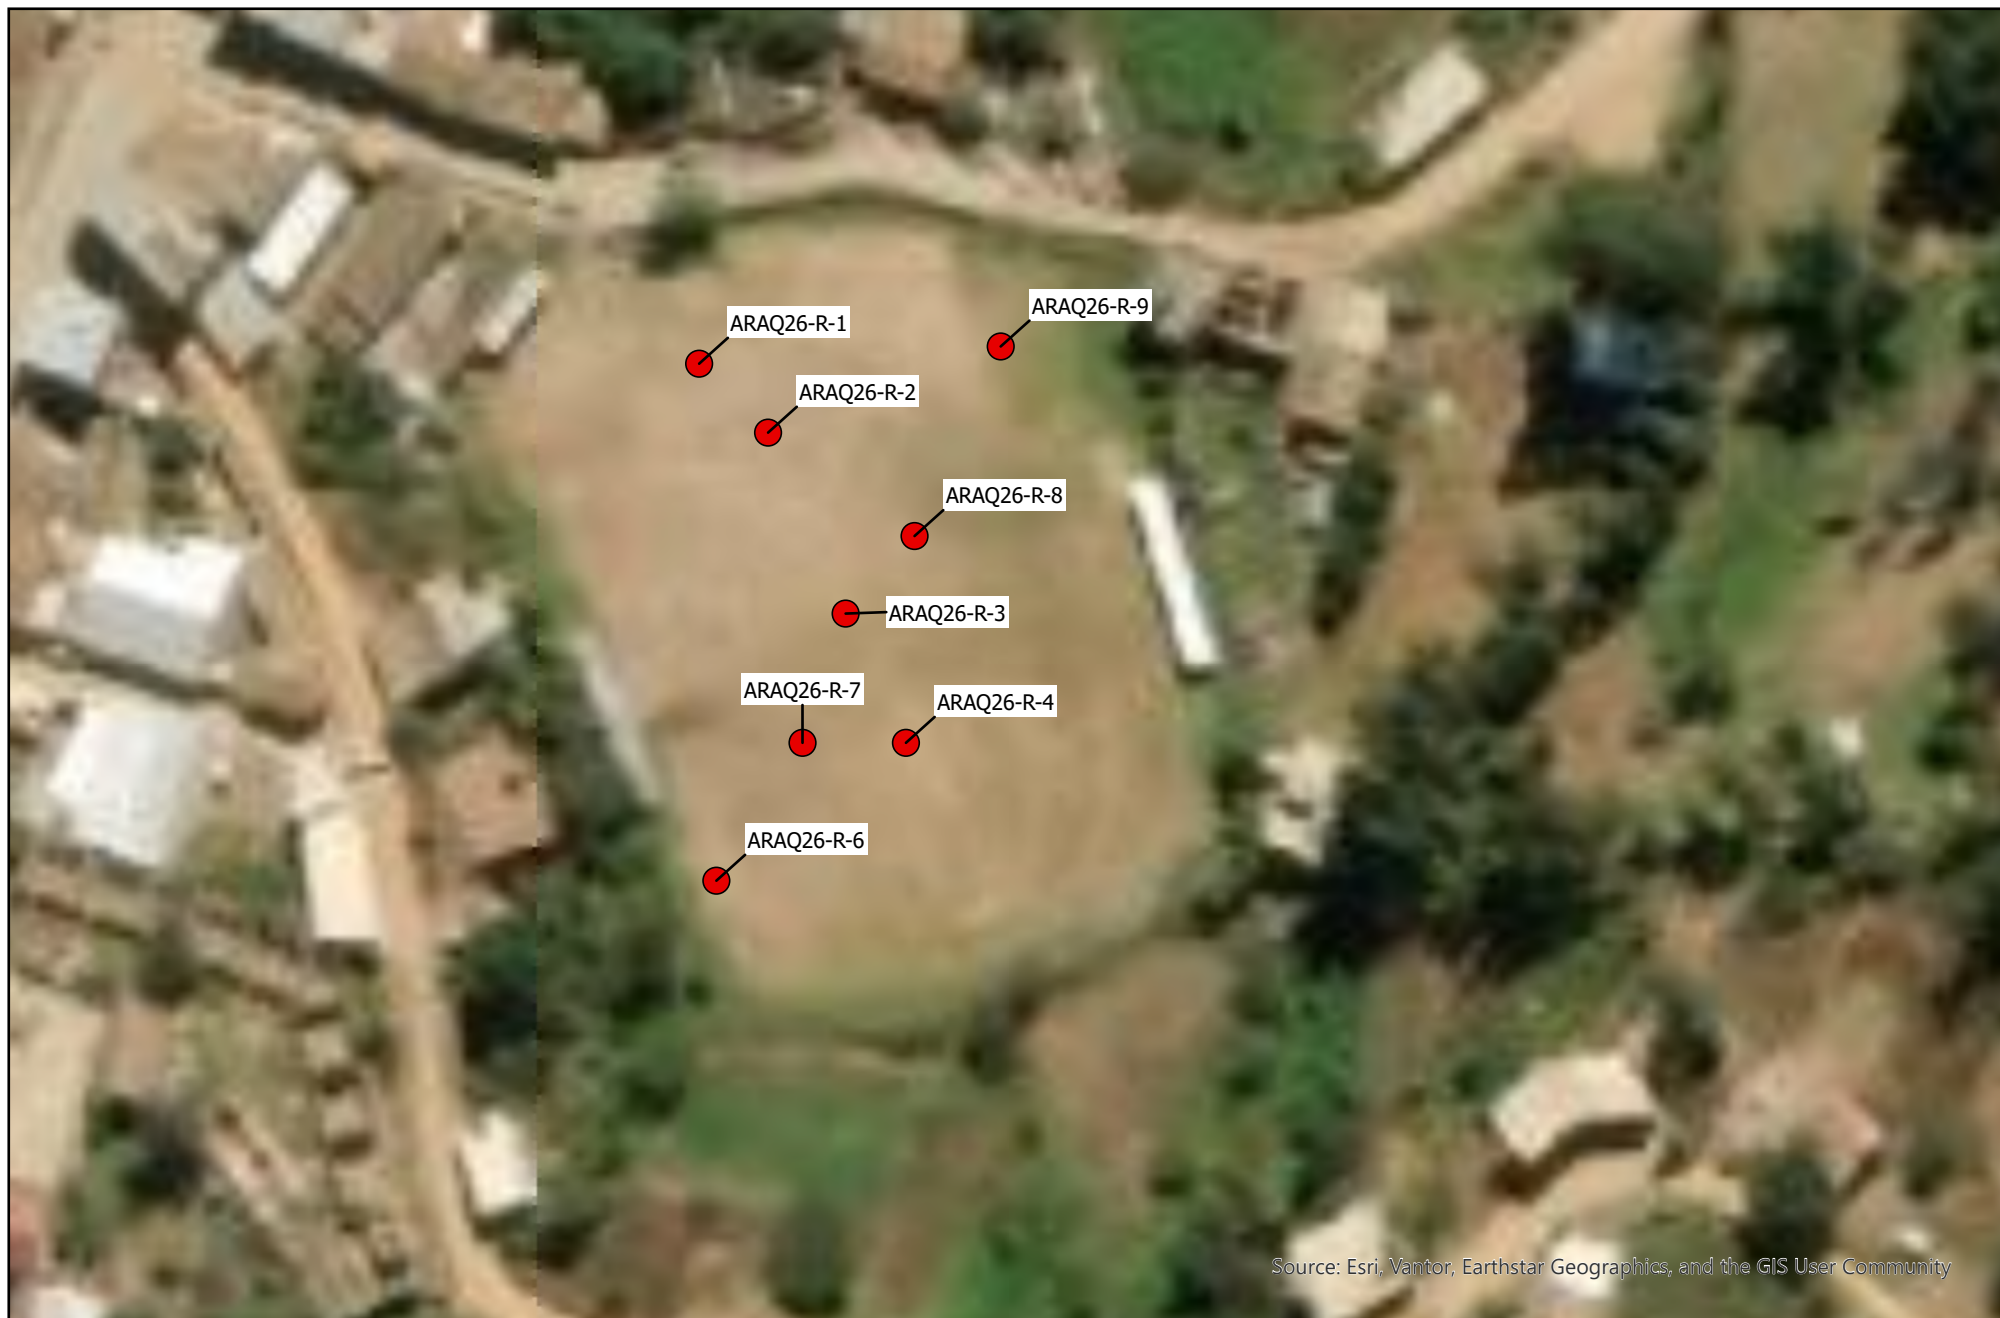
Soil Sample Locations  
July 2026  
Araqueda Soccer Field  
Araqueda, Cajamarca

Twelve soil samples were collected in specific spaces of the Araqueda sports area and park were evaluated. Samples were collected from the following spaces: 1) Public Sports Field and 2) Public Playground (in front of I.S Araqueda).

As results in soil range from 38 to 135 ppm and 10 of 12 sample results exceed the ECA of 50 ppm. The highest concentration was detected at sample location ARAQ26-R-7 at 135 ppm which exceeds the ECA by 2.7 times.

Hg results in soil range from 3.3 to 9.9 ppm and 4 out of 12 sample results exceed the ECA of 6.6 ppm. The highest concentration was detected at sample locations ARAQ26-R-3 and R-7, both at 9.9 ppm which exceeds the ECA by 1.5 times.

Pb results in soil range from 26 to 222 ppm and 2 out of 12 sample results exceed the ECA of 140 ppm. The highest concentration was detected at sample location ARAQ26-R-9 at 222 ppm which exceeds the ECA by 1.6 times.

1. *Most critical points of contamination:* The samples ARAQ26-R-1, 2, 3, 4, 6, 7, 8, 9, 11 and 14 (Sports field and public playground) show levels that are in excess of the ECA for the 3 contaminants analyzed.

1. Delimit and restrict access to the public sports field area (ARAQ26-R-1, 2, 3, 4, 6, 7, 8 and 9, not ruling out ARAQ26-R-11 and 14) contaminated with mercury and lead.

3. Cover the contaminated area with clean materials (with soil not contaminated by metals), putting layers of clean soil and geotextile, followed by grass on top to avoid direct contact and the generation of dust. Also to reduce future exposure, damaged grass or exposed soil, should be replaced with grass or other healthy vegetation.

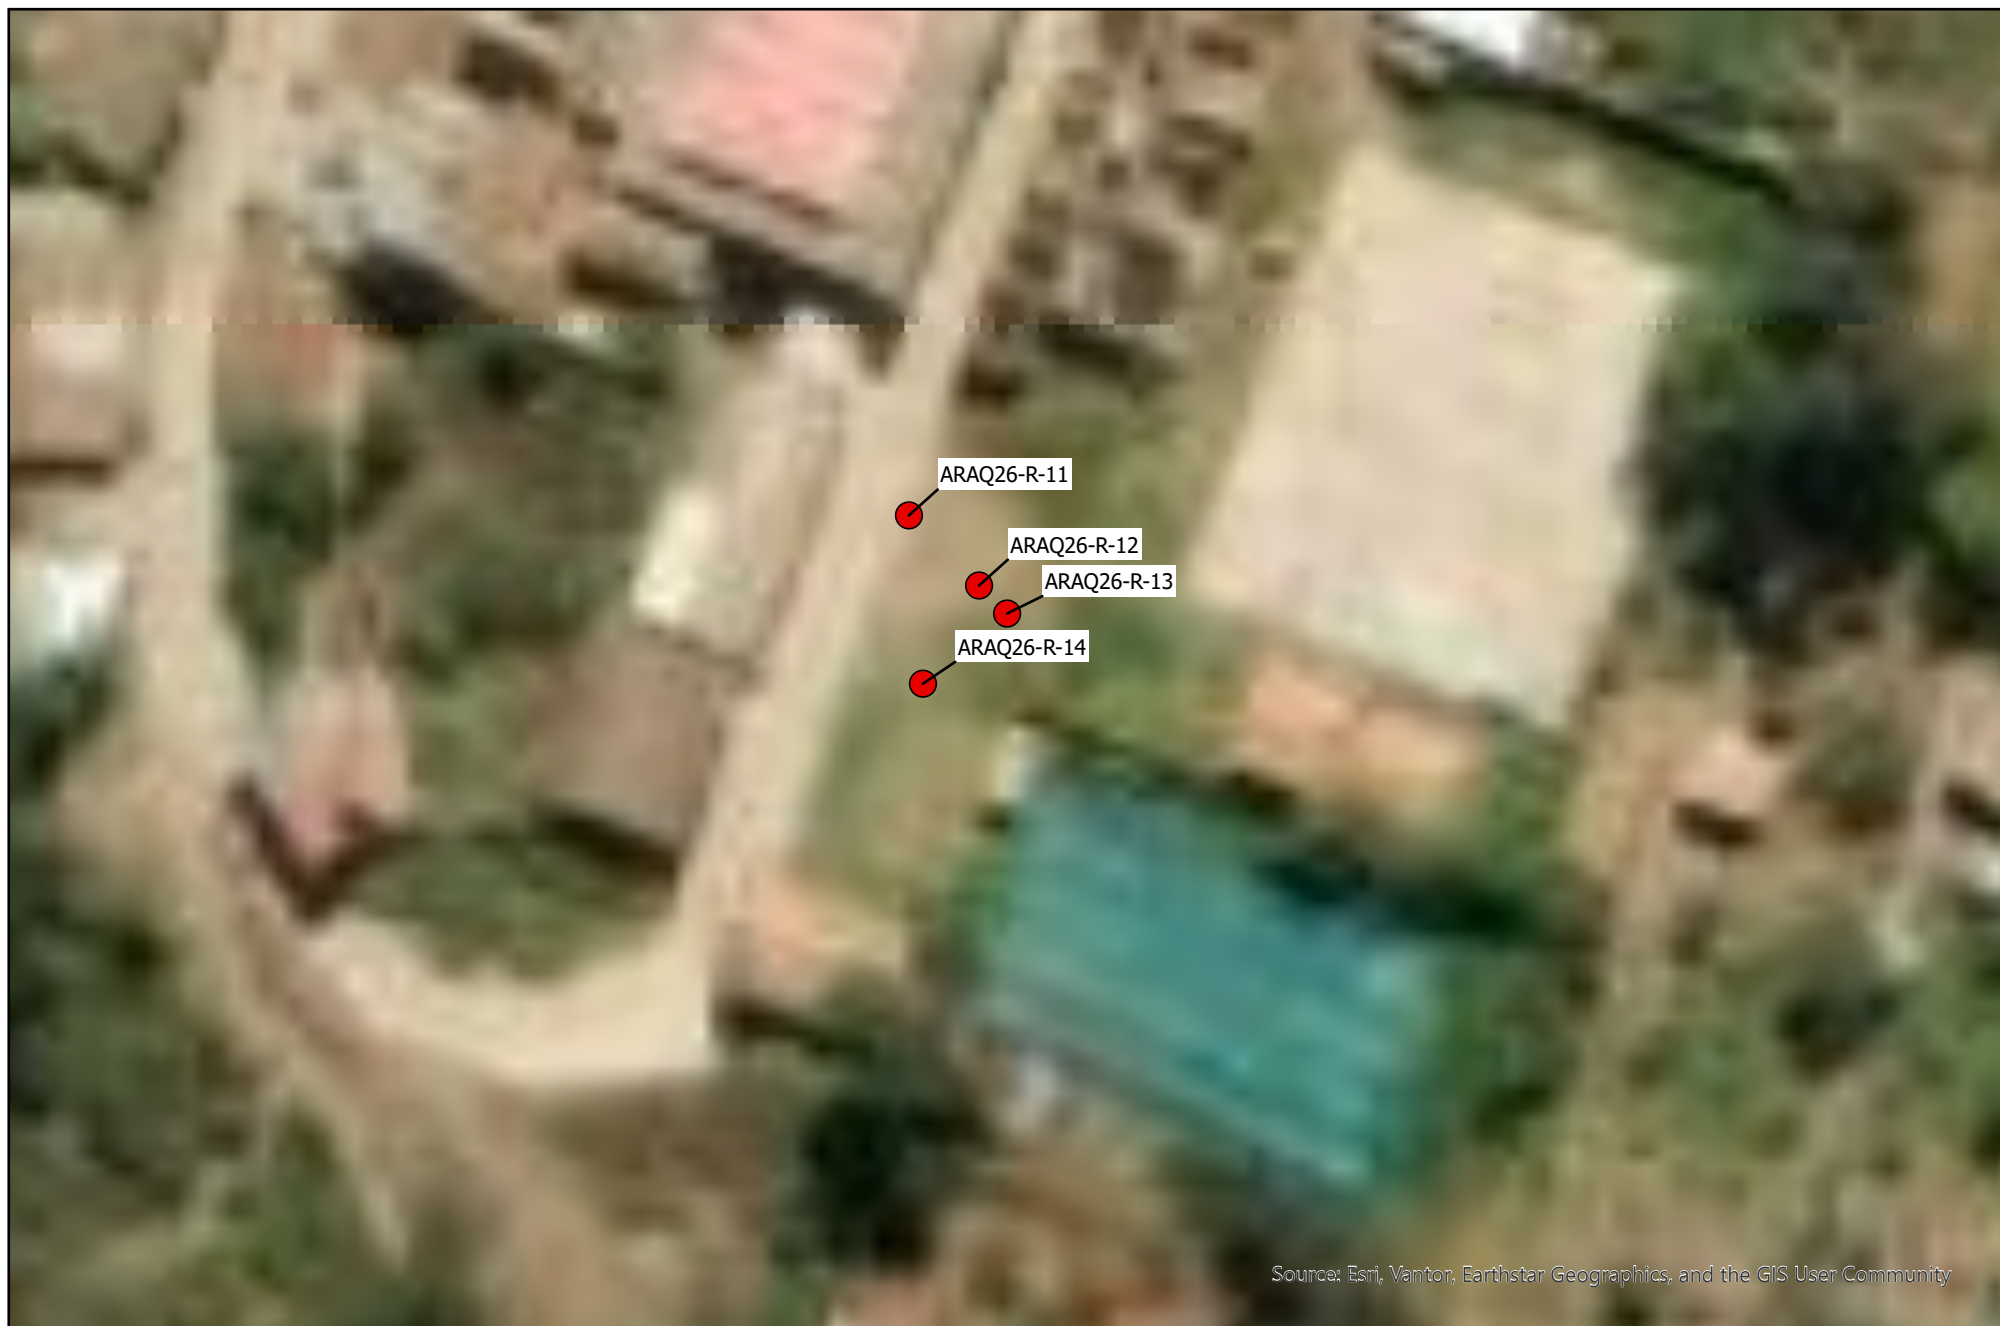
Soil Sample Locations  
July 2026  
Ninos Felices Playground  
Araqueda, Cajamarca

2. *Localized contamination in Araqueda:* Soil contamination in the area is not homogeneous. Samples ARAQ26-R-12 and 13 have levels of 2 metals below the ECAs. Samples ARAQ26-R-1, 2, 3, 4, 6, 7, 8, 9, 11 and 14 show significant contamination for all three contaminants.
