Soil Evaluation of the School Grounds of Early Education Institution No. 538-3 in Quichas, Oyón District and Province, Lima Department, Peru

Report of Results and Recommendations

Report date: October 30, 2025

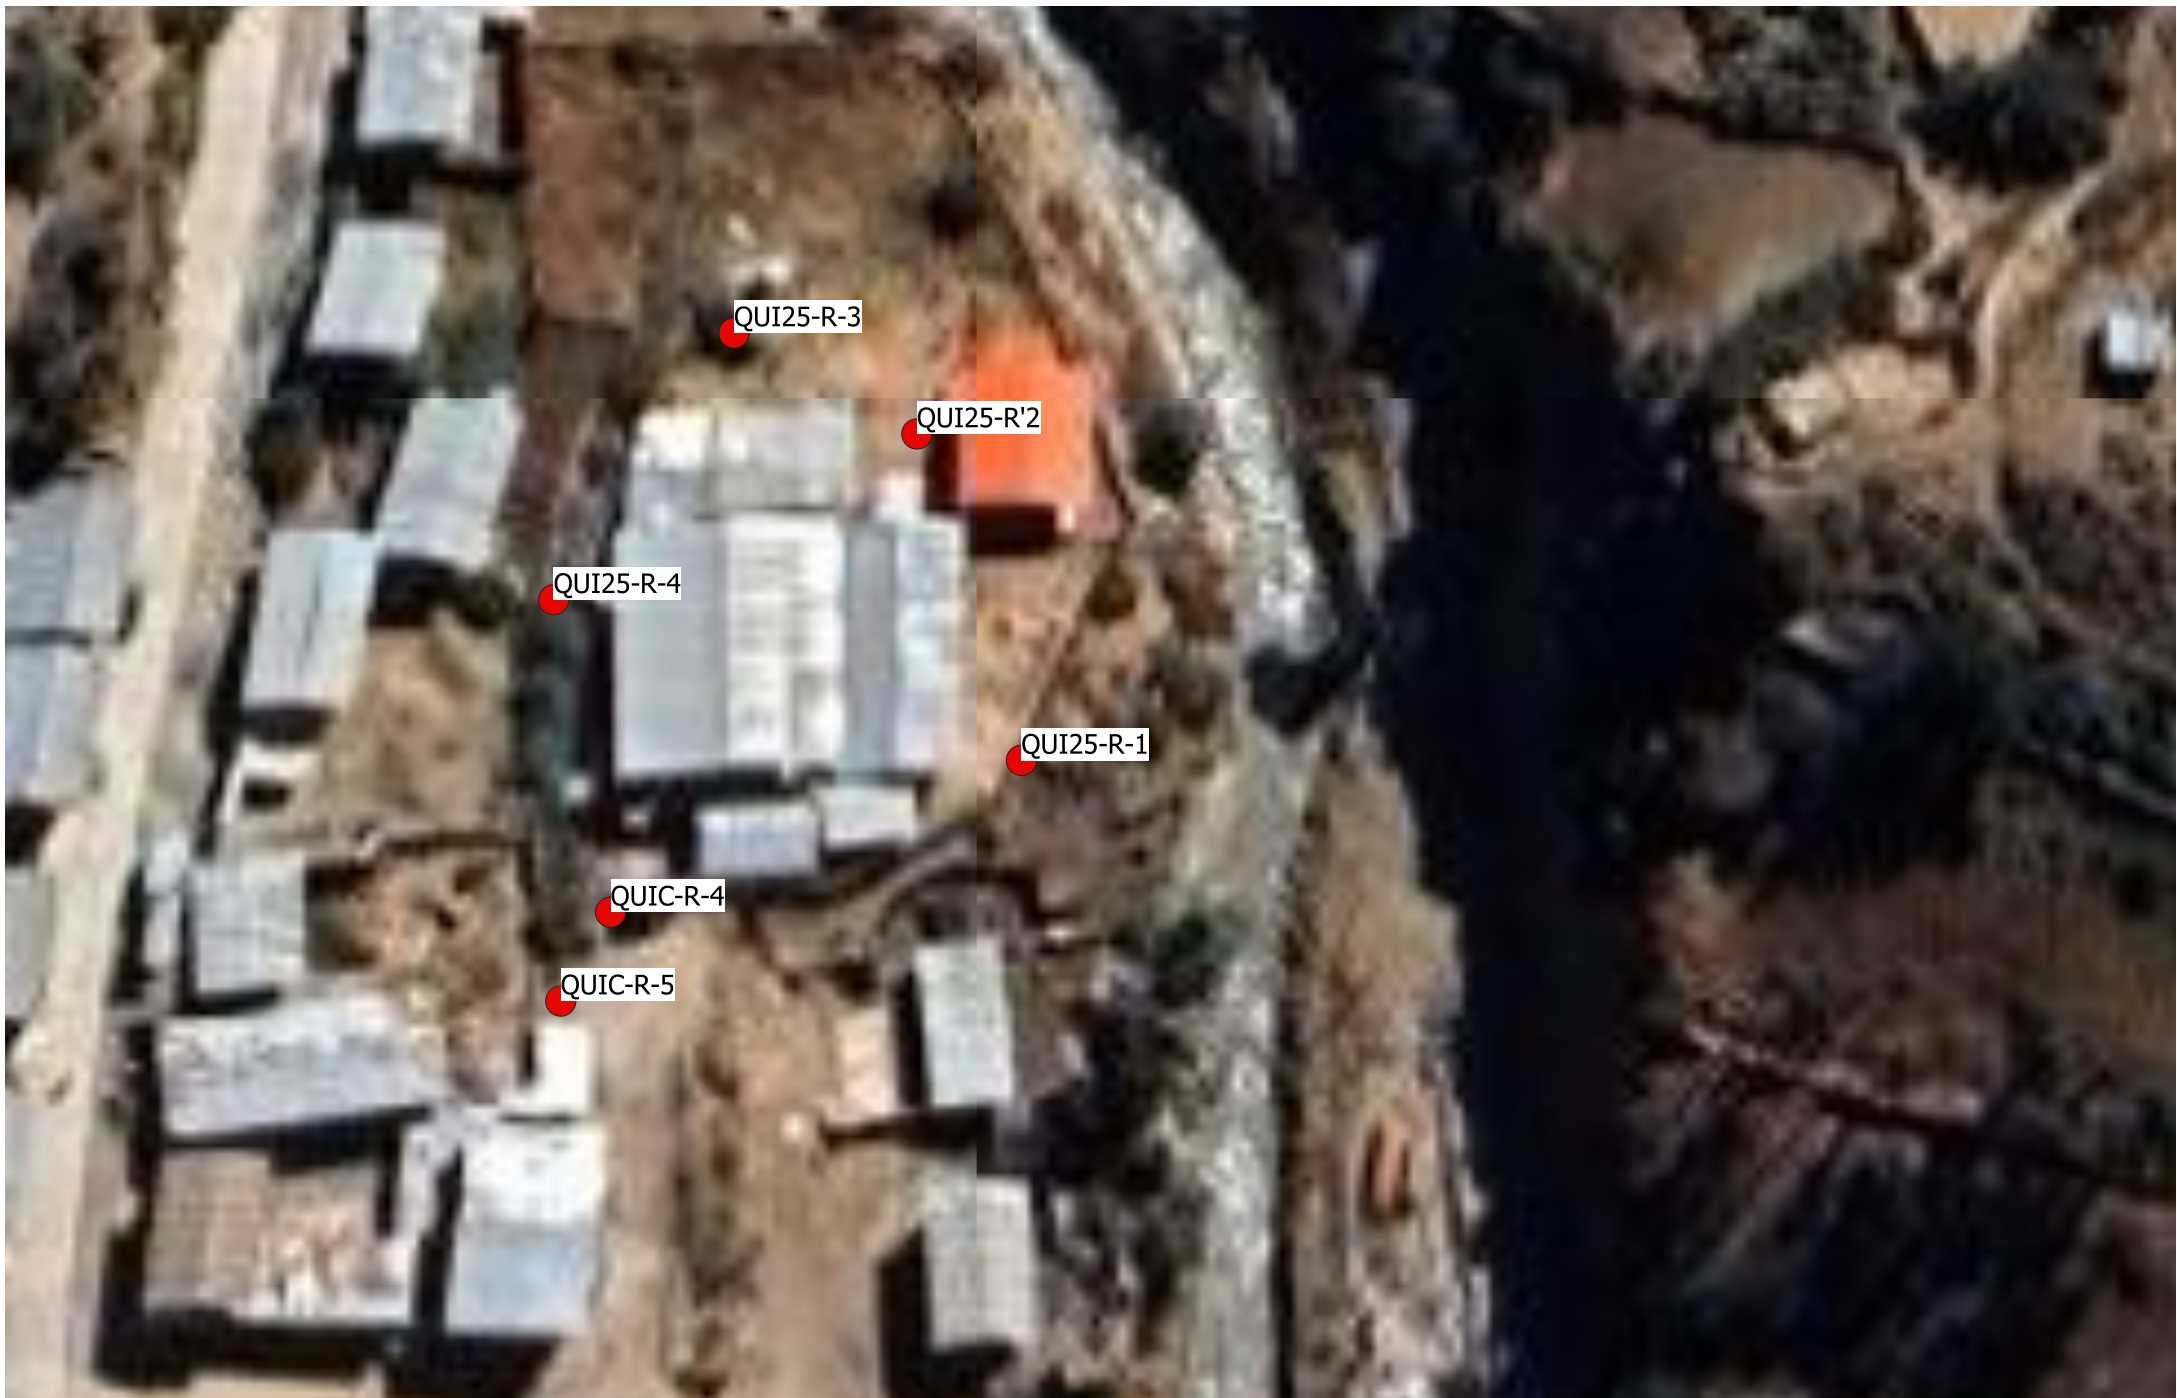
Soil Sample Results
IEI 538-3 School Grounds and Nearby
Quichas, Oyon, Peru

1. School Entrance (QUI25-R-4):
This sample shows alarming levels; exceeding the ECA by 21 times for arsenic, 10 times for mercury, and 16 times for lead. This area is of concern as it coincides with the main entrance of the school.

2. Schoolyard (QUI25-R-1, QUI25-R-2, and QUI25-R-3):
This area shows concerning levels of contamination as several parameters are several orders of magnitude above their respective ECAs. In addition, this area is the most likely area on the schoolgrounds where children interact with soil (ie playground, general outdoor area, and garden).
3. Outside of School grounds near entrance (QUI-R-4 and QUI-R-5):
This area has very high levels of all three heavy metals, suggesting that this is at or near the site of an historic furnace or milling operations. This is further suggested by the reference to this site by Antonio Raimondi in his work *Ancash* (p. 235) and *El Perú* (Vol. 1, p. 257; Vol. 5, p. 98).

1. Immediately restrict access to contaminated areas, especially the school entrance and schoolyard.
2. Conduct additional evaluation of the soils in and around the school and wider community.
3. Remove contaminated soil and dispose following appropriate disposal requirements or cover the contaminated areas with clean materials, applying layers of clean soil and geotextile fabric, followed by grass, to prevent direct contact and dust generation.
