**Soil evaluation of the school grounds of IEI No. 1615 Gloriapampa in the  
District of Conchucos, Province of Pallasca,  
Department of Ancash, Peru.**

**Report of Results and Recommendations**

**Report date:** July 19, 2026

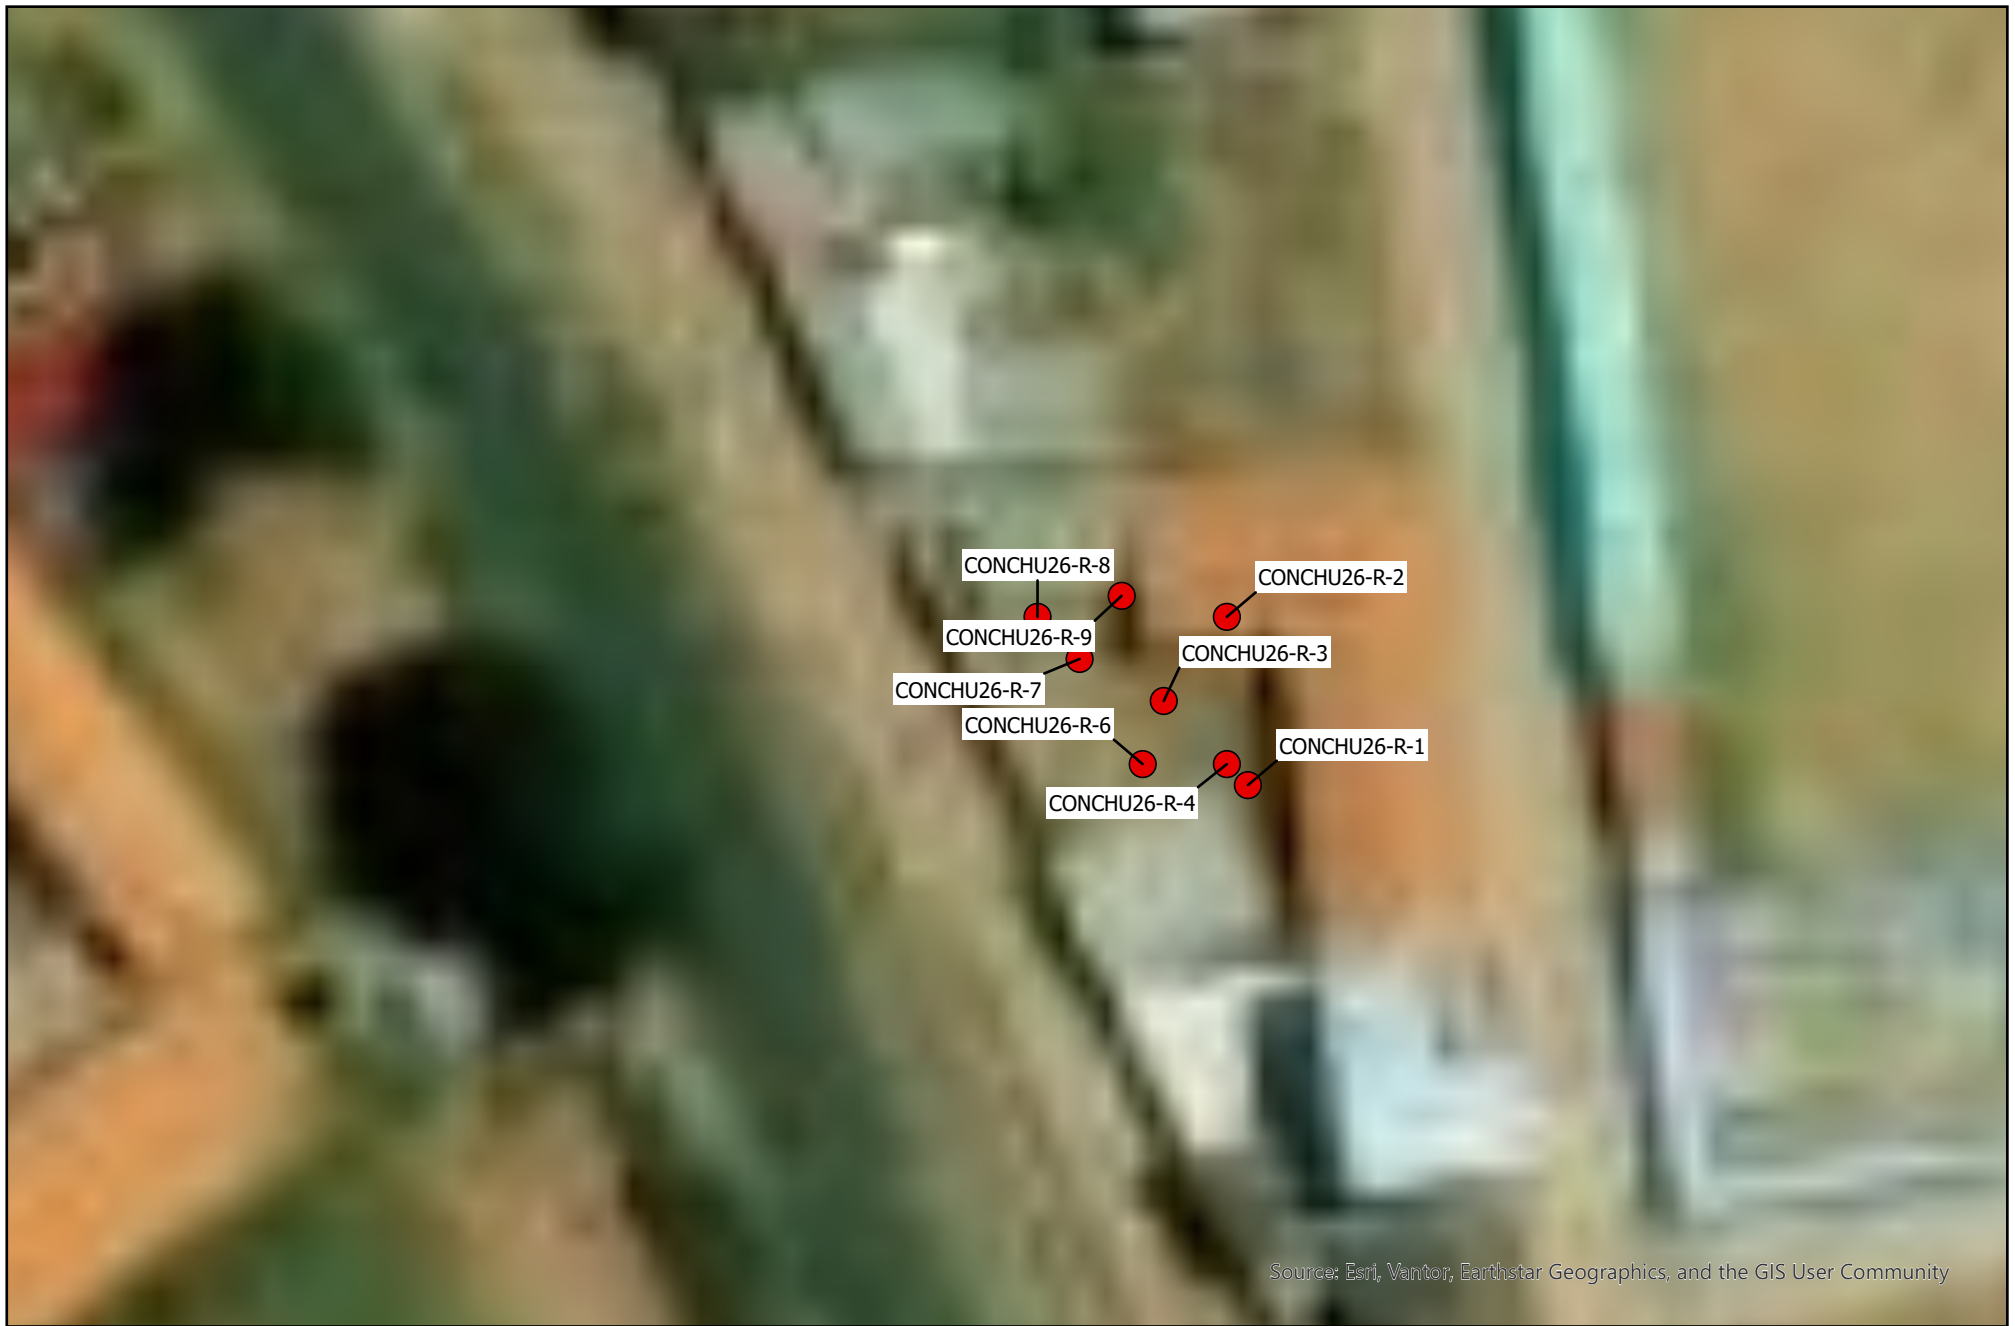
**Attachment:** Figure – Sample Locations

8 soil samples were analyzed in the following spaces: 1) South Playground and 2) North Playground

Soil Sample Locations  
July 2026  
IE 1615 Gloriapampa  
Conchucos, Ancash
